Lessons Learned Database

Issue Number: 304

Author: Mike Leighton

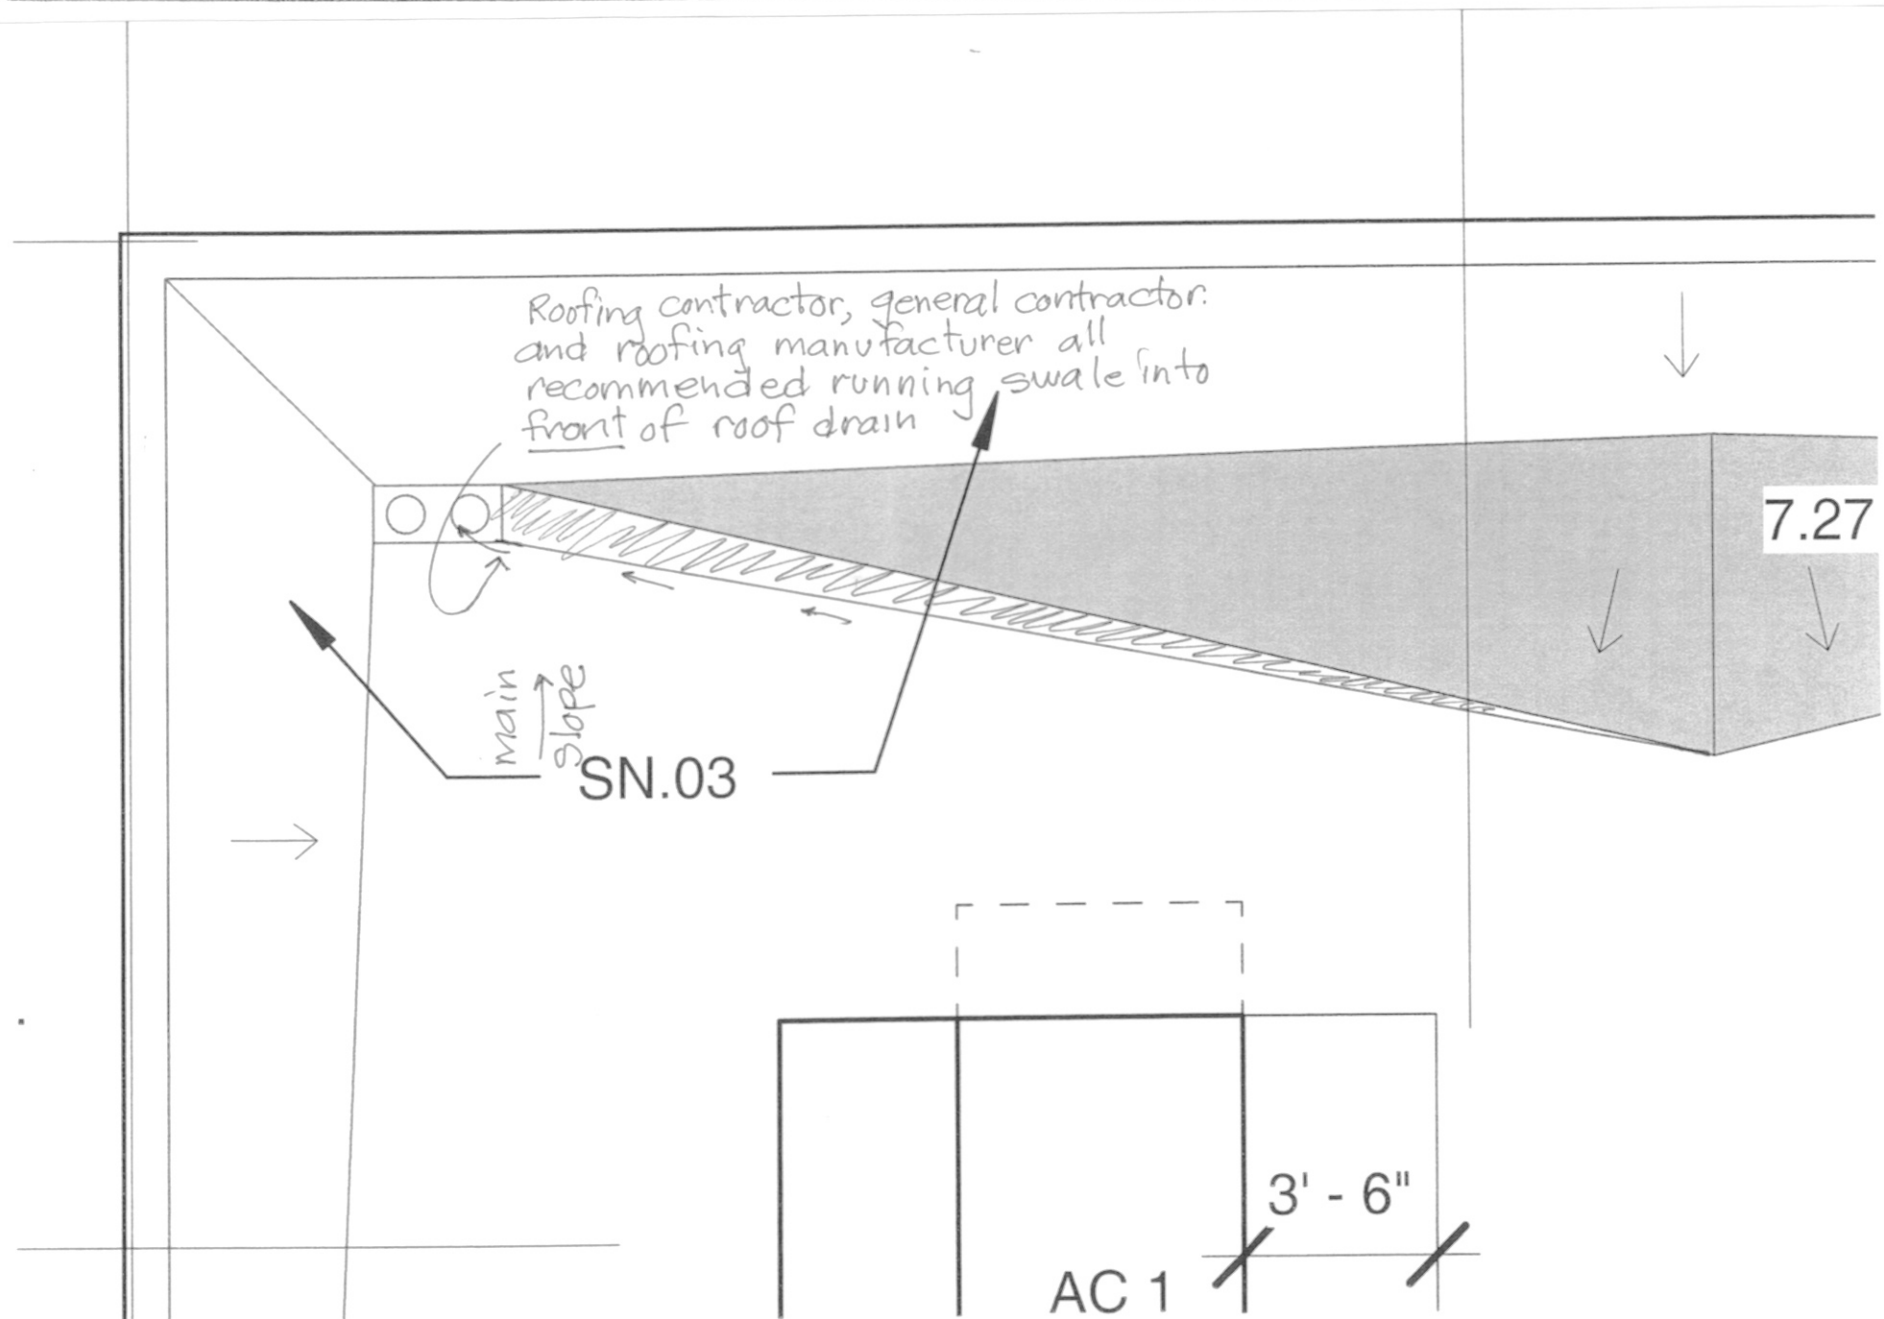
Project Type:	Phase: Design Development	Issue: Flow line from roof cricket was shown to the downslope side of the sump for the roof drain and overflow.	
Building Type:	Specification Section:		
Room Type:	Drawing Type: Roof Plan		
Material:	Consultant:	Resolution: The contractor, roofing contractor and, more importantly, the GAF manufacturer's warranty representative said the better place to align the flow line is to the upslope side of the sump.	
Equipment: Roof Drains	Trade:		
Component: Mechanical wells	Client Standard:		
Attachments:	Attachments:		
Attachments:	Attachments:		
Add Issue	Delete Issue	Print Issue	Save Issue
